TUDOR GROVE, GARDEN SHED
Old Lynchburg Road (Route 631)
Charlottesville vicinity
Albemarle County
Virginia

HABS No. VA-1384-A

TUDOR GROVE, GARDEN SHED

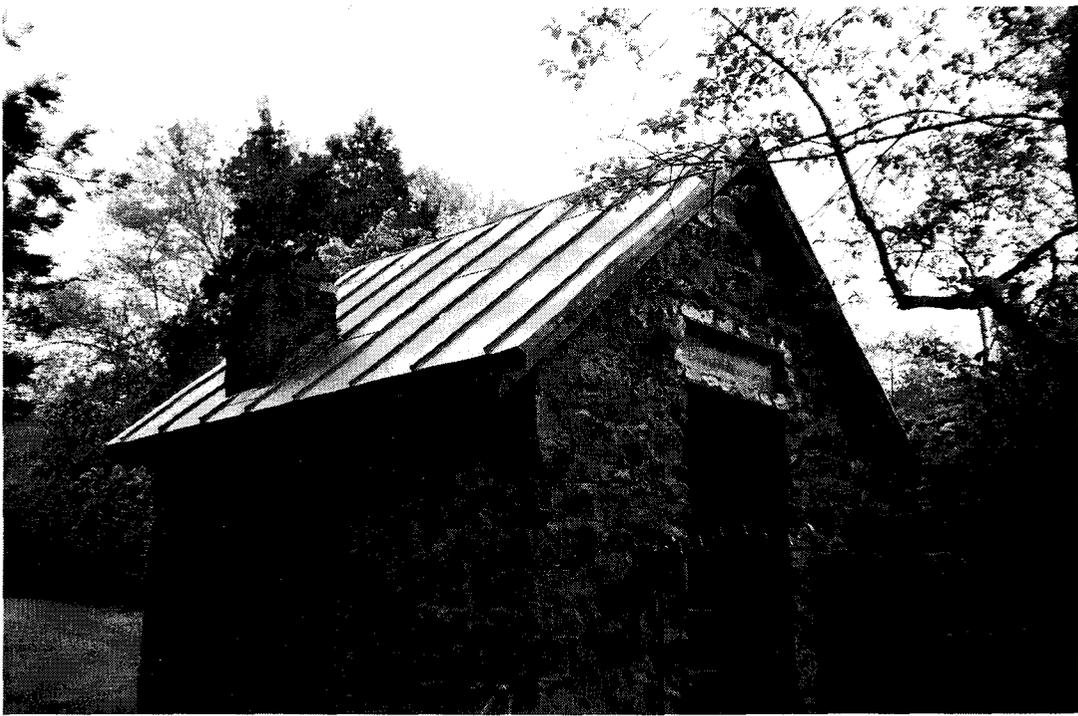
Fig. 2. South-west perspective of the garden shed (entrance door on south façade).

The garden shed is located approximately 75 yards south of the main house (figs. 2-3).

The shed's stone walls are 15" thick; the majority of the fieldstones employed are irregularly shaped, but squared stones are used to accentuate the exterior corners of the building and to frame the doorway (fig. 2) and windows (fig. 8). Dark cement patches are applied in places where the original, lighter mortar has deteriorated; the dissimilar rates of water absorption of the older and newer cements have drawn water into the walls, encouraging further cracking and

intensive ivy growth. For the present, the walls remain quite stable. The only door, a modern replacement, marks the southern gable end as the entrance facade (fig. 2); the east and west walls have a window each, and a circular window punctuates the shed to the north (fig. 3). The apex of each gable is 10'9" above the ground; from here, the stone walls of the gable ends slope down to 6' at the sides. The side walls rise to this latter height, and provide platforms on which the wood roof joists may rest (fig. 4). On the exterior, the stones are left in their natural, rugged state; inside, the stones are flush and whitewashed (figs. 5-6, 8).

The cottage windows of the east and west walls are identically crafted (fig. 8) and centrally positioned (figs. 2-3). Made of green-painted wood, they are the products of mass production, fabricated elsewhere and transported to the site by way of the early and extensive railroad system of western and central Virginia. It is quite likely that most of the materials for this shed, including the stones and original door, are foreign to the site as is typical of both vernacular and elite buildings constructed in the United States after the Civil War. These windows are of a simple configuration, glazed with two-over-two lights, and their ornamentation consists of green paint on the wood frames, black-painted latticework (now faded) upon the lights, and copper lizard handles above which are small swivel locks. The windows are hinged to the left and swing inward. Like those of the door, the window jambs and headers are made of rough, circular sawn boards, painted green, and affixed to the stone wall by way of hidden nailer boards. The windows are flush with the inside face of the east and west walls; the deep window recesses observed from the exterior are smoothed with cement, faced at the sides with wide, green-painted boards, and splayed downward at the bottom.

The chimney (figs. 2-3), rising up through the roof to the north of the west window, is another element integral to the staged decay of this garden folly. It is short and stubby, and crowned by irregular, vertically oriented, small stones purposefully positioned in a ruinous manner; the lower portion of the protruding chimney stack is covered with cement, possibly in conjunction with the patching campaign carried out on the walls below, but the carefully posed stones above remain free from correction. The chimney serves as an exhaust outlet for an interior stove providing immediate warmth for the gardener seeking shelter from chilly spring rains. The metal pipe required for this heating device is still embedded within the chimney, and can be observed on the interior of the west wall (fig. 8). The inclusion of the chimney is twofold; on the one hand, it allows for yet another manifestation of staged decay, while on the other, it signifies the functional aspect of this folly, and its practical use as a garden shed and shelter.

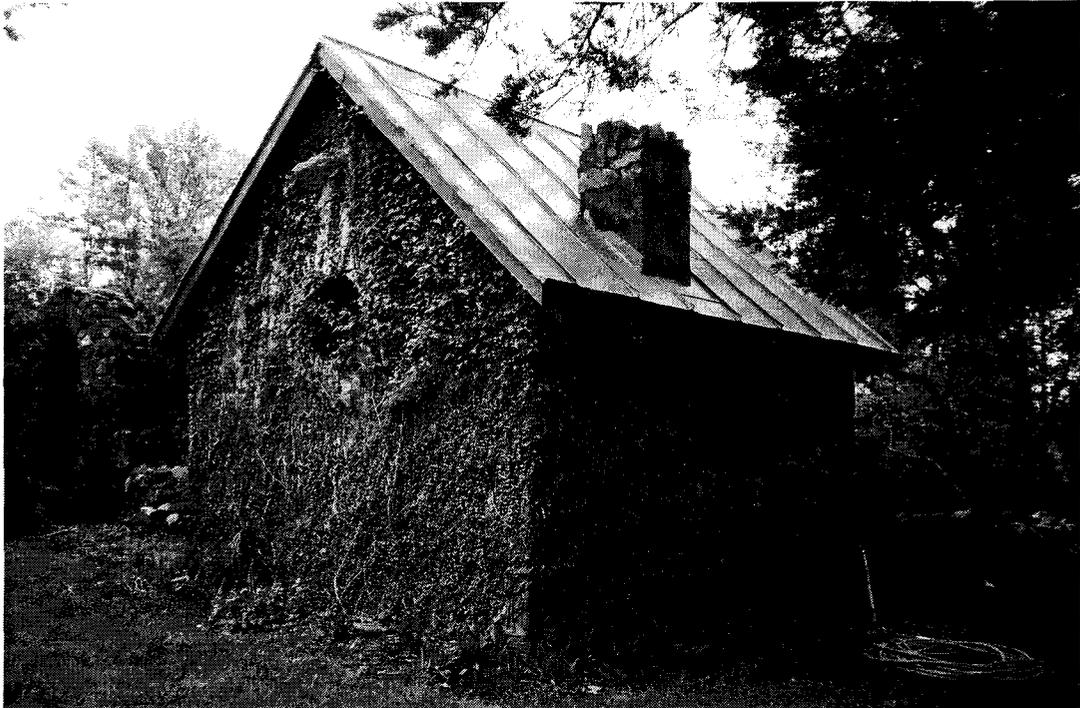
Fig. 3. North-west perspective of the garden shed.

The circular window of the north wall is characteristic of the romantic garden folly of the later nineteenth and early twentieth centuries (figs. 3, 6). While there is a substantial rectangular stone horizontally placed above it, there are many smaller stones and much cement work about the remaining circumference of the window (fig. 6). Like the lintel over the door, it too may be a later insertion suggestive of the structure's long life as a garden folly. As a small-scale

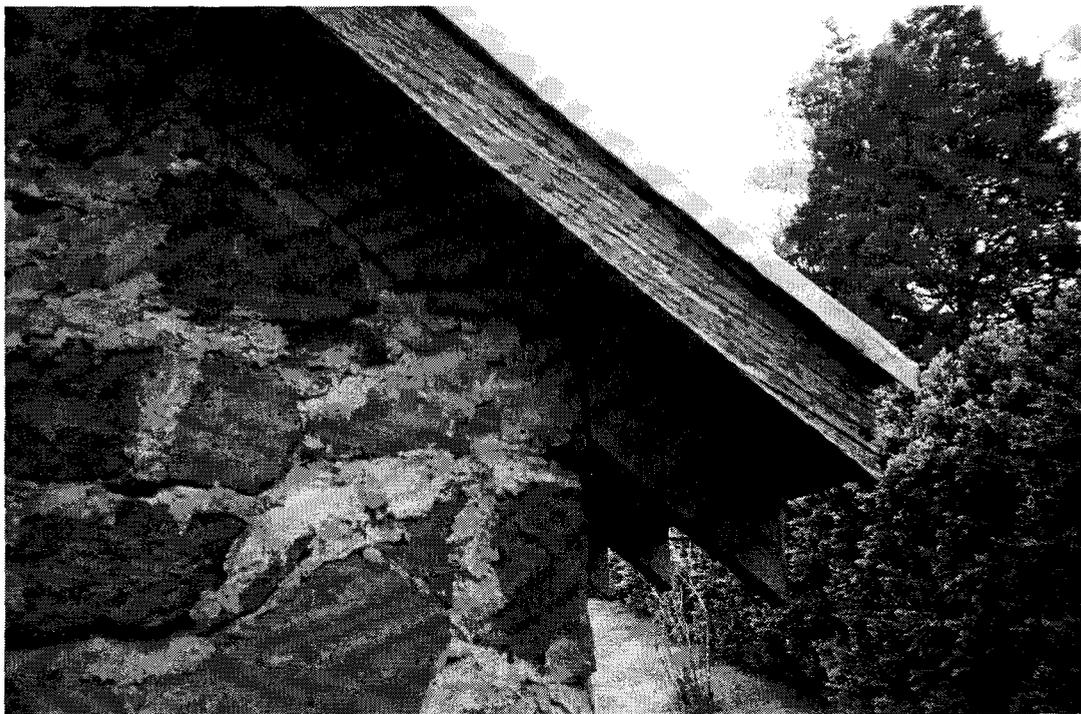
Fig. 4. Exterior rafter detail.

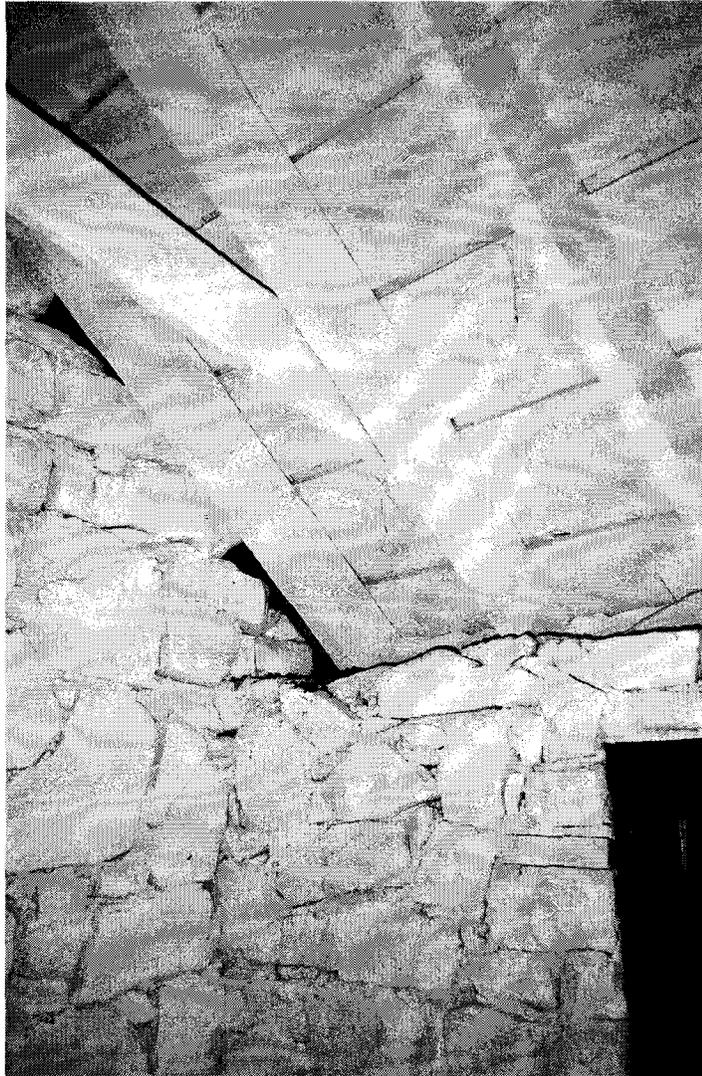
Fig. 5. Interior rafter detail.

The roof framing system is simple, and is perhaps the shed's most definitive dating feature. Flat boards lie atop the side walls at their edge; nicked green-painted rafters, eight per side, rest on top of these boards (fig. 5) running from the eaves to the ridge board in a roof framing system typical of early twentieth-century vernacular construction. For additional support, cross-bracing boards are haphazardly nailed to vertical faces of the two northern-most pairs of rafters (fig. 6). Wide planks are nailed on top of and across the rafters, and a standing seam metal roof caps the structure. The roof extends approximately 10 ½" beyond the side walls and approximately 4 ½" beyond the gable ends. At the sides, long 2 x 4s extend horizontally to cover the top half of the rafter ends, while at the gable ends, non-structural rafters, thinner in both thickness and width than their structural counterparts, are attached to the underside of the roof butting into small pentagonal pieces suggestive of Gothic barge boards below the apex. All lumber is circular sawn and secured with machine-made nails, features of post Civil War construction in the South and features used today.

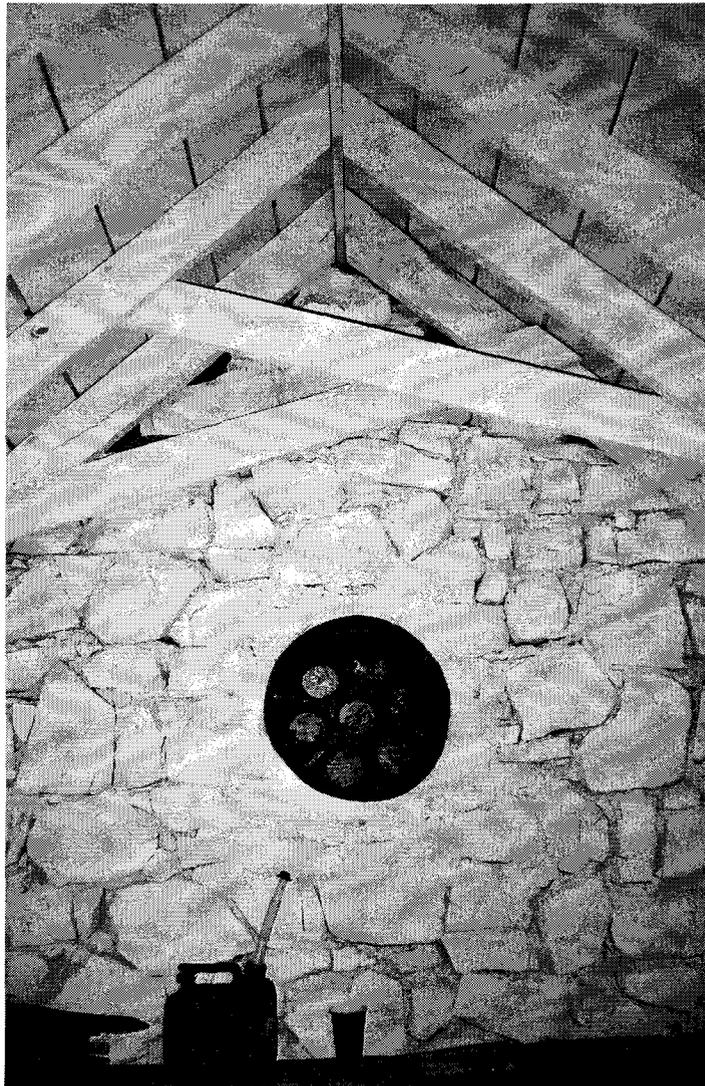
Fig 6. Interior view of north wall.

As if to underline this utilitarian intention, a narrow, green-painted shelf stretches across the inside of the north wall (fig. 6), providing space for seeds and small gardening tools. Although the building may appear to be caught in the early stages of decay, it is, and always has been, quite functionally sufficient for its intended purpose. Unlike its European ancestors, this turn of the century American garden folly is a functional as well as a decorative addition to the landscape. From the outside, swathed in the green growth of Virginia vines, it is reminiscent of the English garden folly, first popularized by Henry Hoare at Stourhead Park in the mid-eighteenth century and it suggests the romantic, Gothic ruin epitomized in England at the turn of the nineteenth century by James Wyatt's Fontill Abbey. Upon entering, however, the function of this folly as a useable shed becomes clear. Space is allotted to the gardener for the storage of the tools of his trade, a stove is provided for warmth, and windows, in combination with a whitewashed interior, ensure a bright pleasant atmosphere in

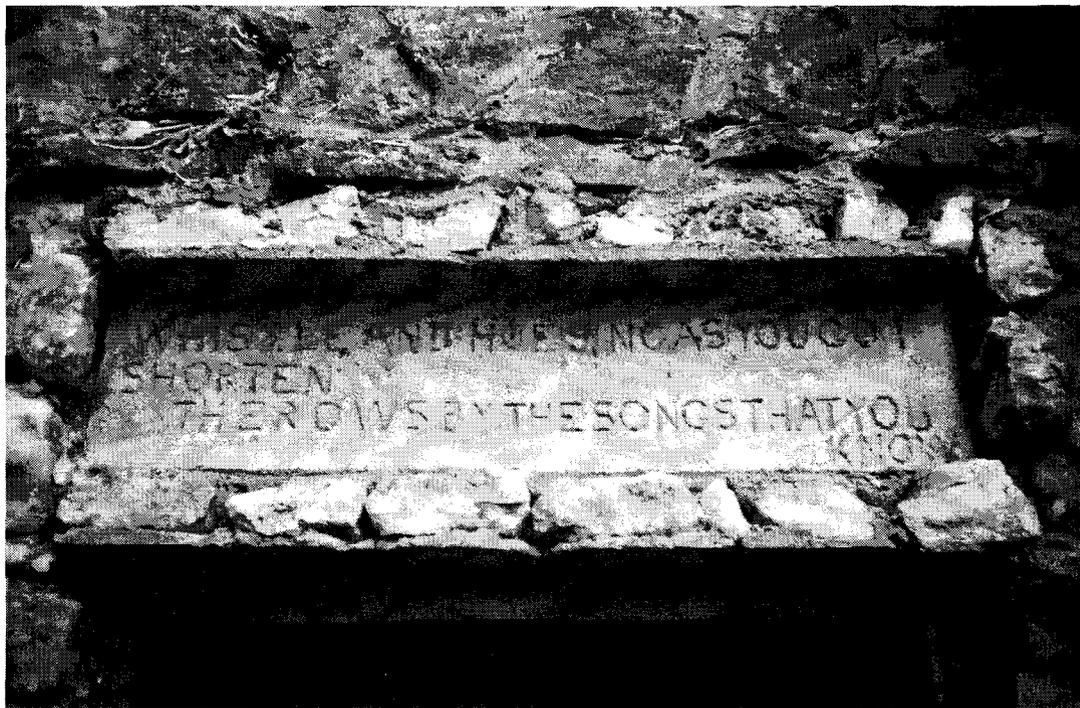
Fig. 7. Lintel above south façade door. The verse reads:

WHISTLE AND HOE SING AS YOU GO:
SHORTEN
THE ROWS BY THE SONGS THAT YOU
KNOW

Wood jambs and a header about the door are also circular sawn and painted green; the six-light green painted door is a modern replacement and its compact plywood material is distinct from the rougher faces of the jambs and header. On top of the header rests a thin, flat stone slab, on which sit half a dozen small, squat stones that support a concrete lintel slightly wider than the 2'8" doorway (fig. 7); topped by a second thin, flat slab and more small stones, this lintel is probably a later insertion interrupting the large-stone pattern of the shed's walls. The lintel is carved with poetic lines celebrating soil cultivation: "WHISTLE AND HOE SING AS YOU GO: (/) SHORTEN (/) THE ROWS BY THE SONGS THAT YOU KNOW." The capitalized lettering is uneven, and the words are not fitted to even lines, but they clearly state the intention of the shed

as a garden folly.¹ The Jeffersonian sentiment of the romantic American landscape as a garden paradise is commemorated by this crudely cut, simple, nursery-rhyme verse, which invokes the image of the happy gardener blissfully toiling in the peaceful paradise of the American land.² The fact that this lintel may be a later insertion does not negate the folly's intent; rather the lintel intensifies it suggesting that the shed's symbolic use as a folly has been maintained over time.

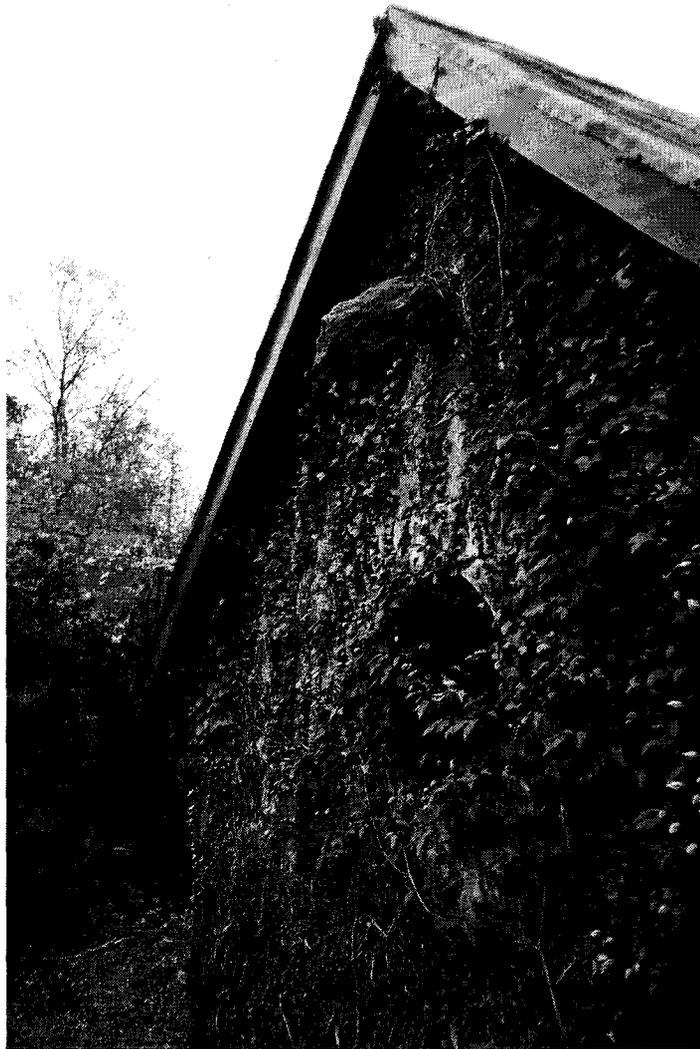
Fig. 9. Reptilian grotesque protruding from north wall.

domestic version of the magnificent rose windows of the great Gothic cathedrals, the window is comprised of seven small circular panes of clear glass fit into a concrete disc out of which seven corresponding holes have been cast. The pattern of seven circles is not aligned with the apex of the roof; the top-most circular pane is off-center, accentuating the nature of the shed as a garden folly in a state of ruin. Above the window, a curious reptilian head of carved stone protrudes from the wall (fig. 9), evocative of the grotesques of sacred and secular French medieval architecture. Unprotected by the overhang of the roof, the head has eroded from the rain in a natural process of decay, but two eyes and a mouth slightly upturned are clearly visible.
