Boone/Truly Ranch, Main House
11119 NE 185th Street
Bothell
King County
Washington

HABS No. WA-218-A

WRITTEN HISTORICAL AND DESCRIPTIVE DATA

THE BOONE/TRUELY RANCH
MAIN HOUSE

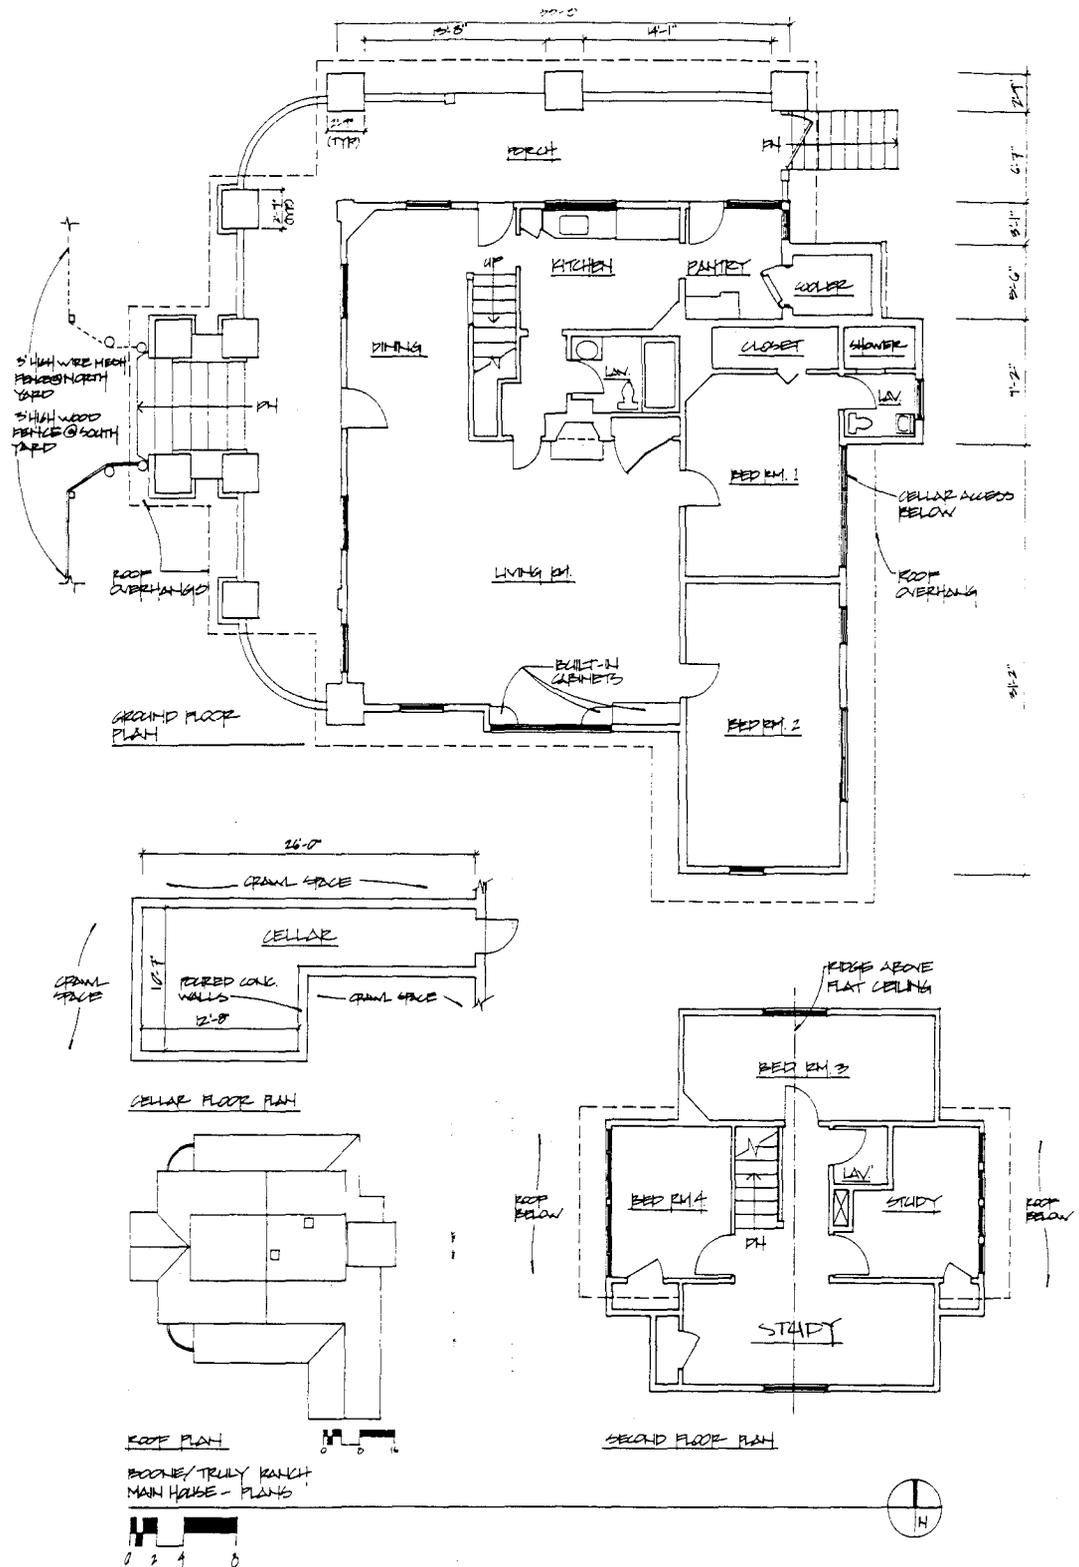
Figure 1. The Main House, Plans. Source: Boyle • Wagoner Architects, January 1997.

The Boone/Truly house interior has an arrangement of rooms that clearly separate larger public spaces and smaller private ones. The spatial emphasis is on the "L" shaped living room/dining area space. These rooms share a long perimeter west wall. The west wall has three windows, as previously described, and the main door which is centered above the exterior porch stairs. The north wall shows evidence of an enclosed fireplace at the northwest corner in the dining area.

The north wall of the living room is comprised of a narrow door with plain trim opening from a storage alcove, a fireplace with a glazed tile hearth, and a wide gun closet with a two-panel, hinged door. Two similar-sized bedrooms are accessed through doors in the east wall. A built-in cabinet, with glass-paneled doors, is situated at the east corner of the south wall. The depth of the cabinet is equal to the 1'-8" projection of the window bay.

Three bedrooms, a small bathroom and a sitting area are located on the second floor. Wood stairs, traveling south, approach a landing at approximately the center of the house. Two high ceiling, bright bedrooms, with windows near the top of the wall flank the stairs and corridor to the east and west. The third, rectangular bedroom encompasses the north third of the second floor. Large windows, although north facing, allow plenty of natural light and views of the cattle pens and side yard. A small, centrally located bathroom and a study/sitting area occupy the remaining space. Due to its southern exposure, the study retains warm light throughout the day. Strap detailing, similar to the porch piers, is present in the newel posts of the stair balustrade. A large, paneled hatch on plain hinges with handles can be closed horizontally to prevent infiltration of cold air to the second floor.
