Boone, Truly Ranch, Wash House
11119 NE 185th Street
Bothell
King County
Washington

HABS No. WA-218-B

THE BOONE^WTRULY RANCH
WASH HOUSE

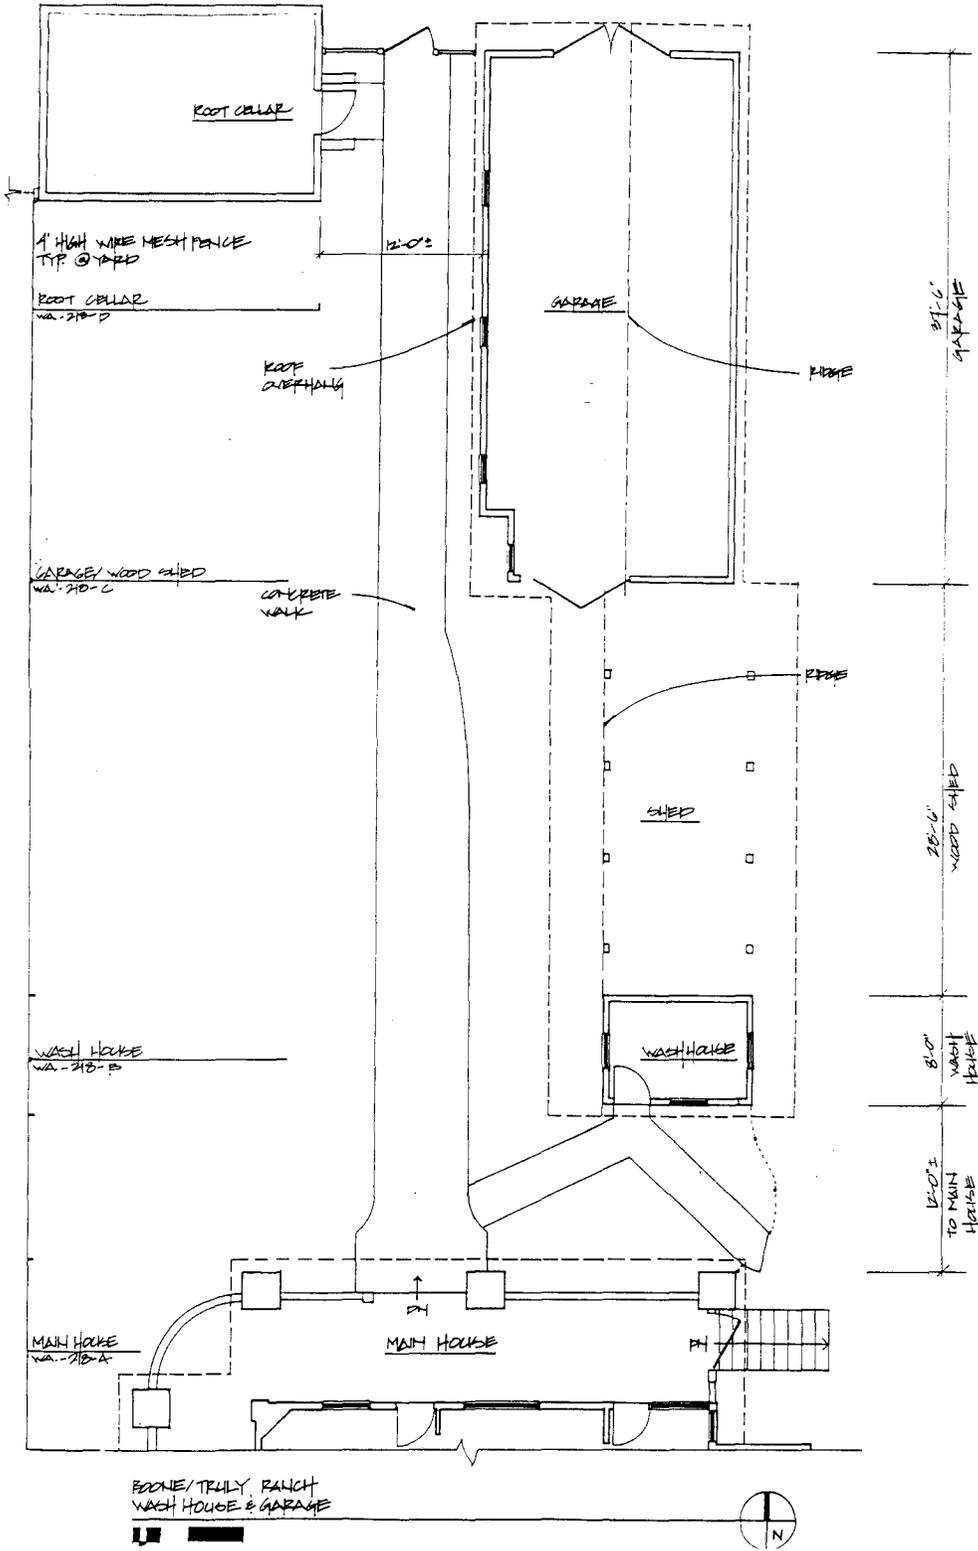
Figure 1. Plan of the domestic assembly of buildings -- the Main House (WA-218-A), Wash House (WA-218-B), Garage/Wood Shed (WA-218-C) and Root Cellar (WA-218-D), Boone/Truly Ranch.
Source: Boyle • Wagoner Architects, January 1997.
