CEDARBURG COVERED BRIDGE
National Covered Bridges Recording Project
Spanning Cedar Creek on a bypassed section of Covered Bridge
Road
Cedarburg
Ozaukee County
Wisconsin

REDUCED COPIES OF MEASURED DRAWINGS

CEDARBURG BRIDGE

HAER No. WI-117

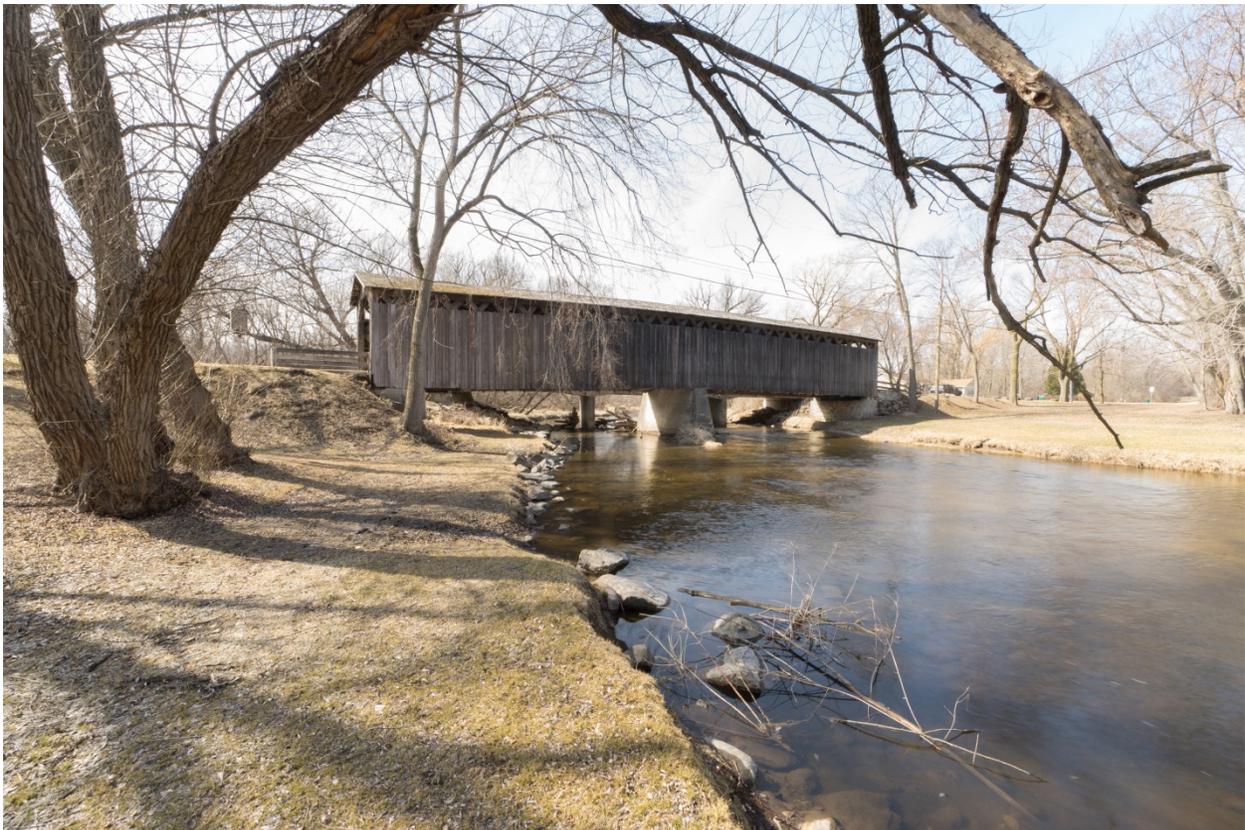
Figure 1. General view of Cedarburg Bridge over Cedar Creek; view to west.

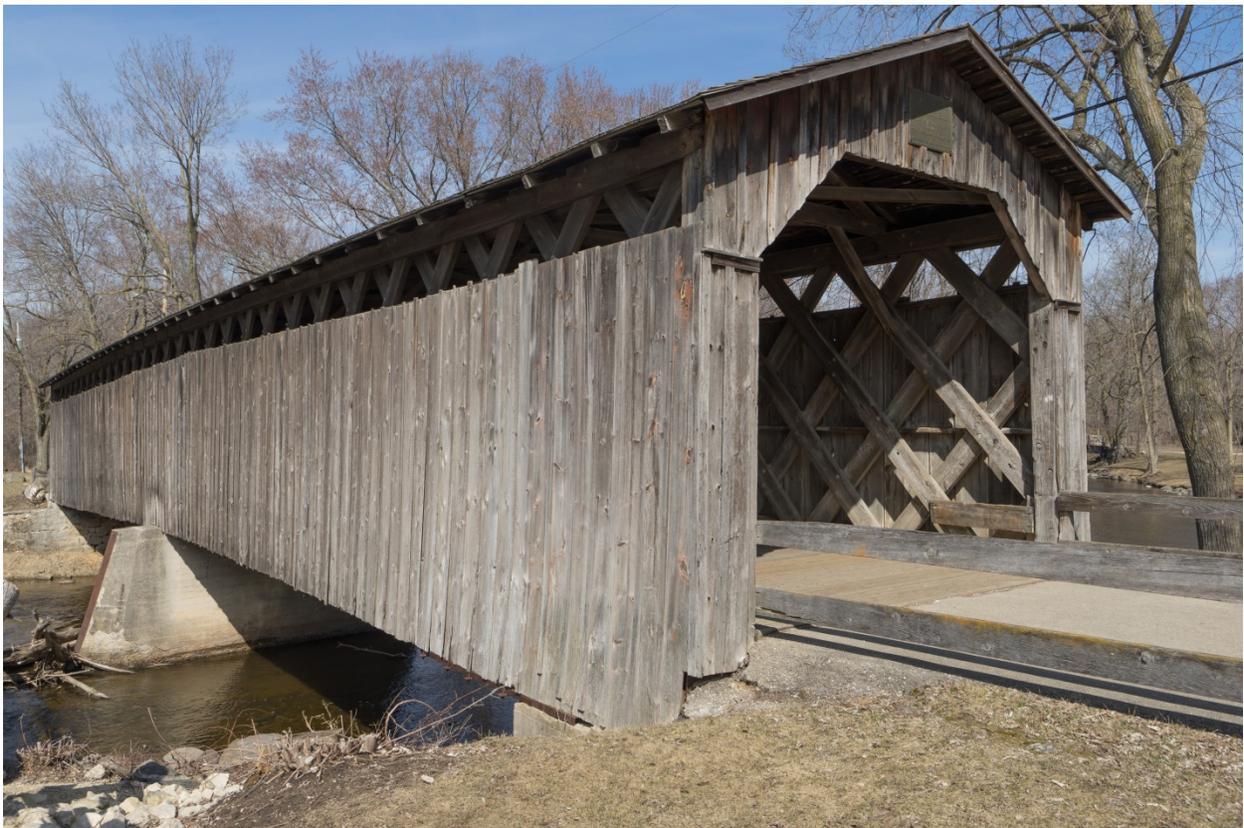
Figure 3. General oblique view west and south sides, view to northeast.

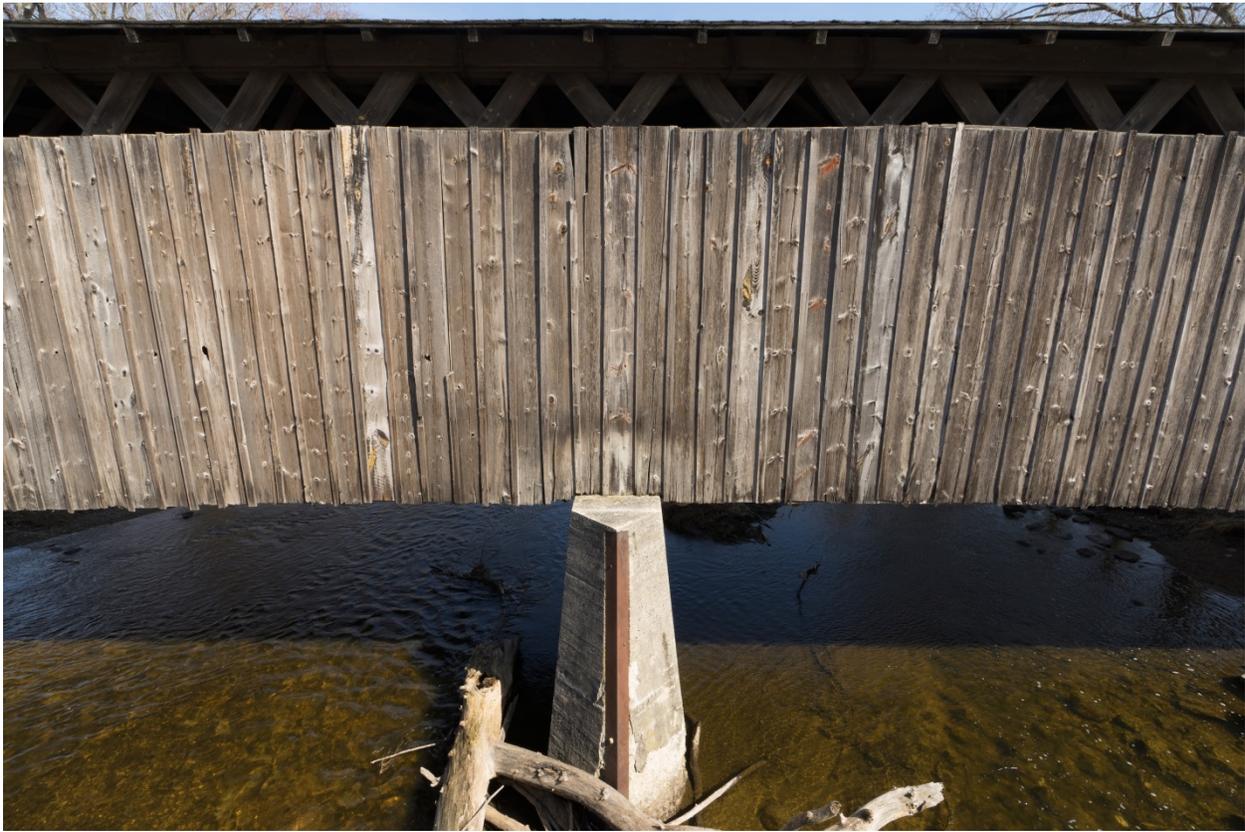
Figure 4. Detail west side, center pier; view to east.

- The lower chords rest on mortared stone abutments, with a supplemental center pier added in 1927. The deck consists of 2"x6" laminated boards, sitting atop 6"x8" stringers. They are supported by a pair of 3"x12" floor beams spaced at approximate 8' intervals, reinforced by 4"x6" lower lateral bracing. The bridge is sheathed with board and batten siding. A 1'-10" clerestory opening runs the entire length of the bridge. It is sheathed by board and batten siding, with a cedar shingled roof.

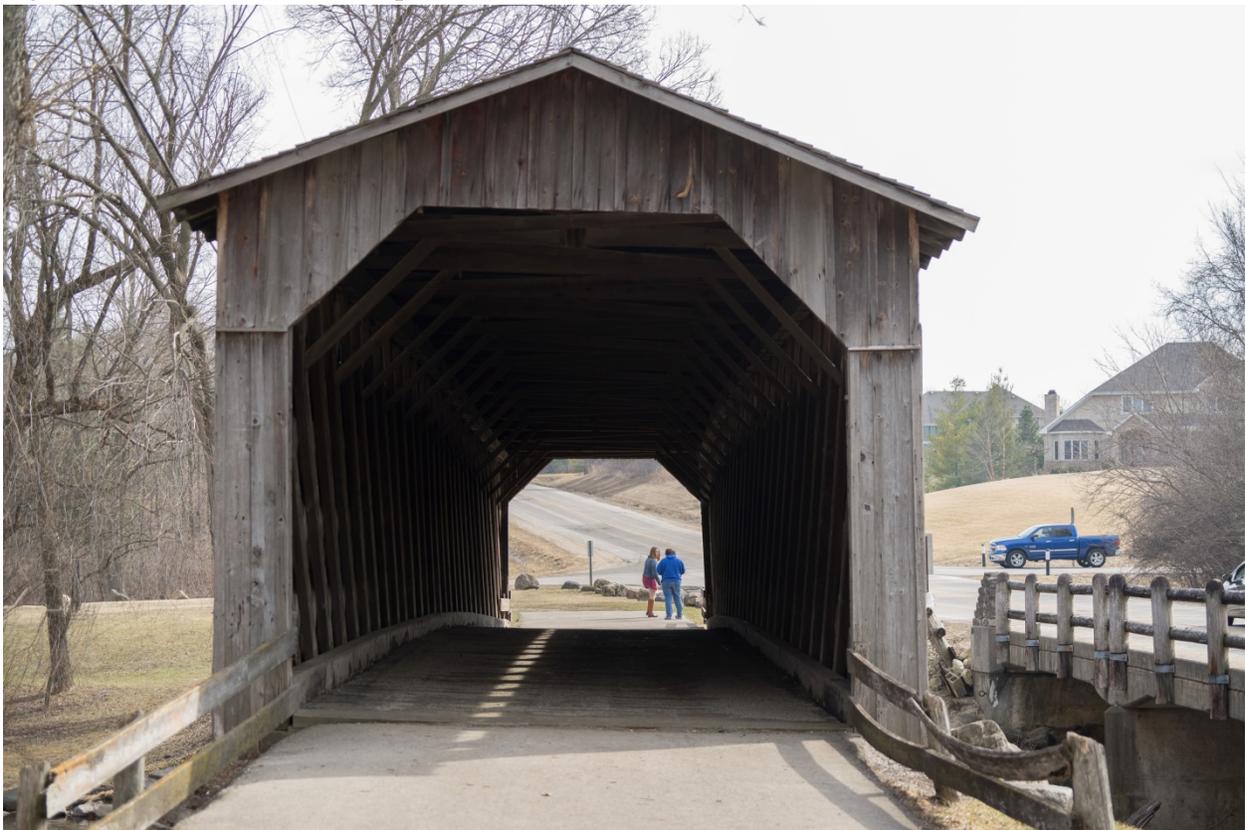
Figure 5. North portal, showing residential development in distance; view to south.

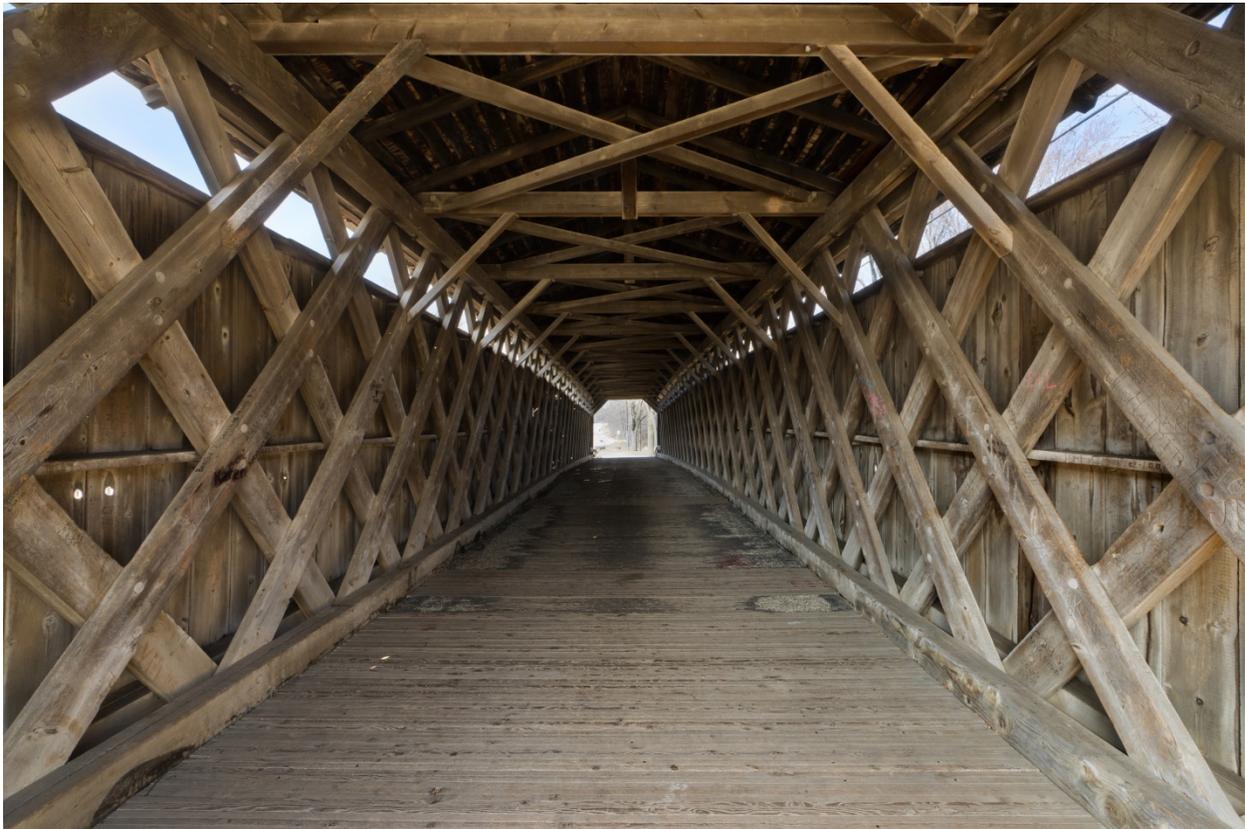
Figure 6. Interior view of deck from south to north

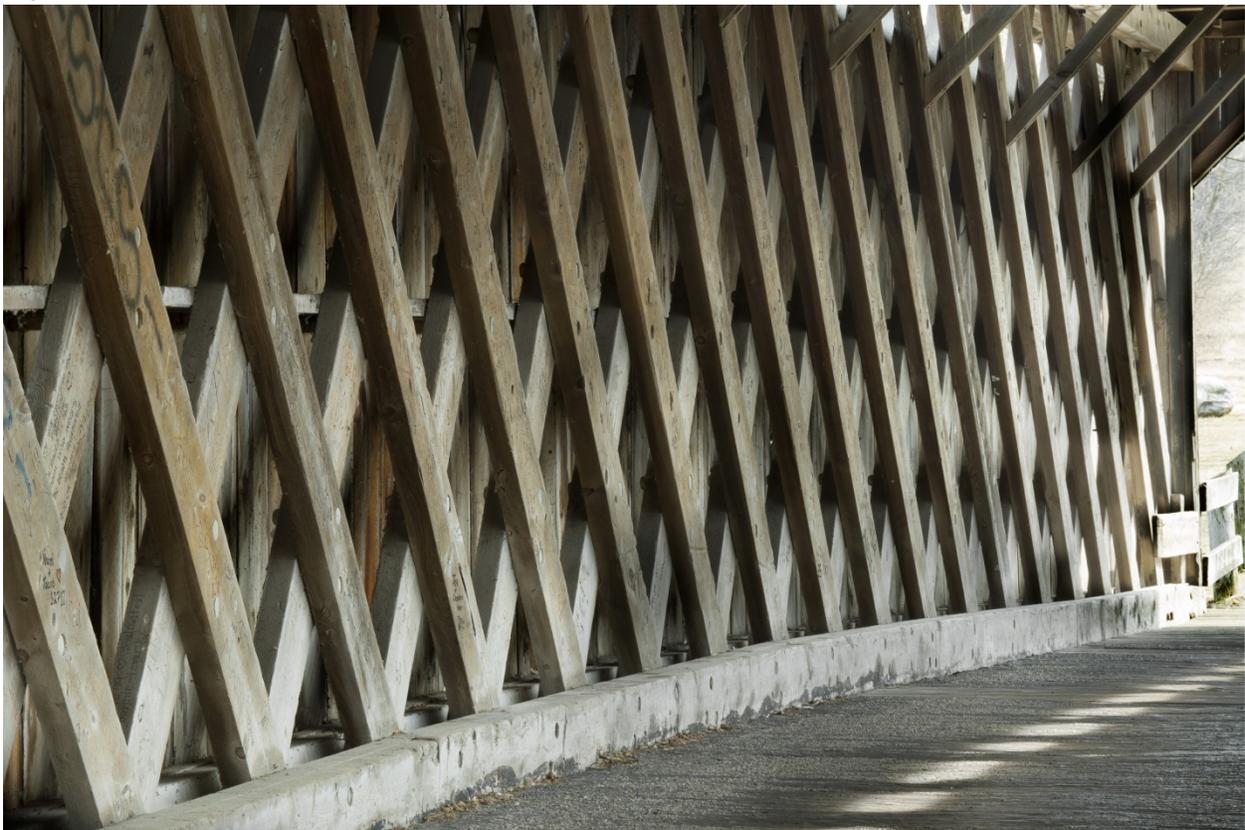
Figure 7. Interior oblique view of east truss; view to southeast.

- Description:** The Cedarburg Bridge is a single-span Town lattice truss sitting on a supplemental center pier. The total length of the bridge is 120' from portal to portal. The bridge has a vertical clearance of 12', with a roadway width of 13'. The Town lattice truss is three diamonds high, composed of 3"x10" planks, connected by two treenails at each intersection. The typical diamond is 4' wide, 4'-8" high, at a 60 degree angle. The upper and lower chords are two pairs of parallel 3"x10" planks. Where the lattice members meet the chords, they are connected by three treenails.

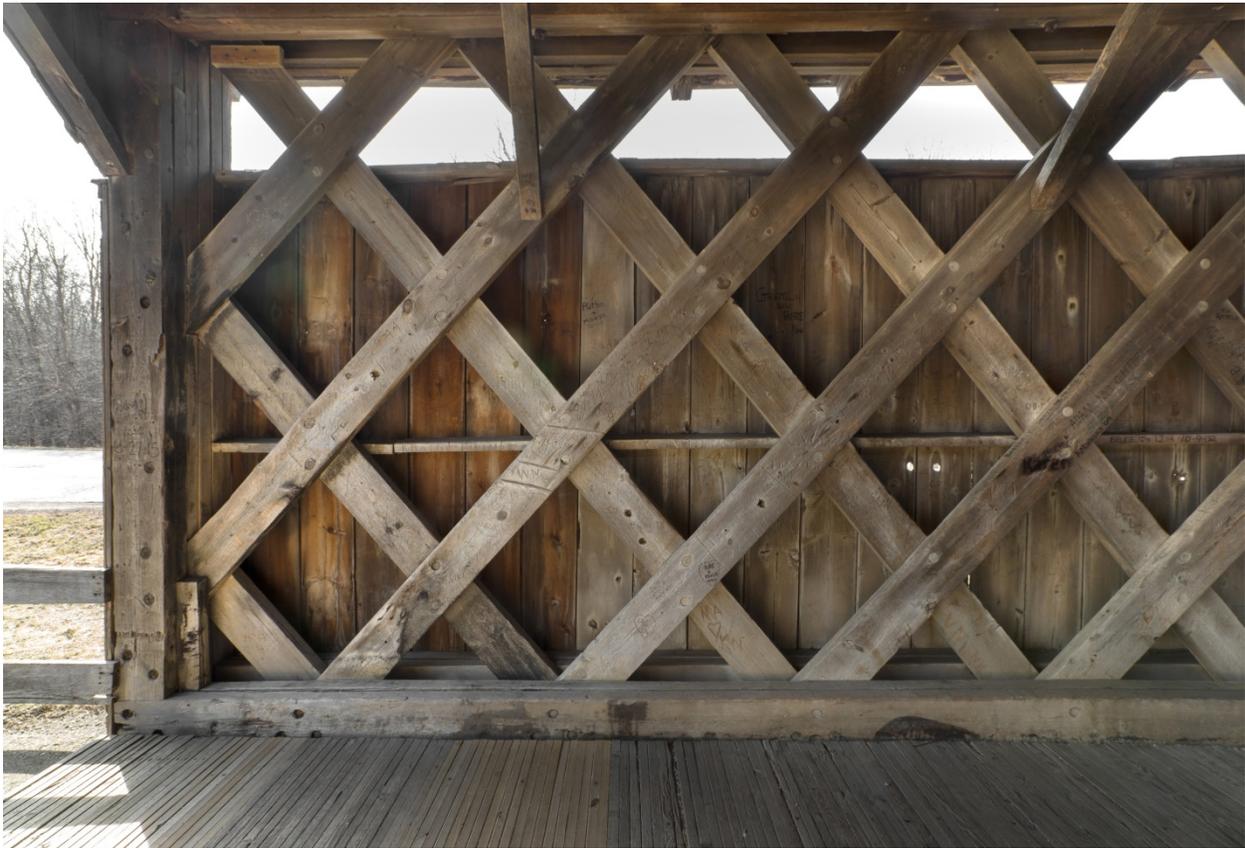
Figure 8. Interior view, south end west side lattice, clerestory and deck, view to west.

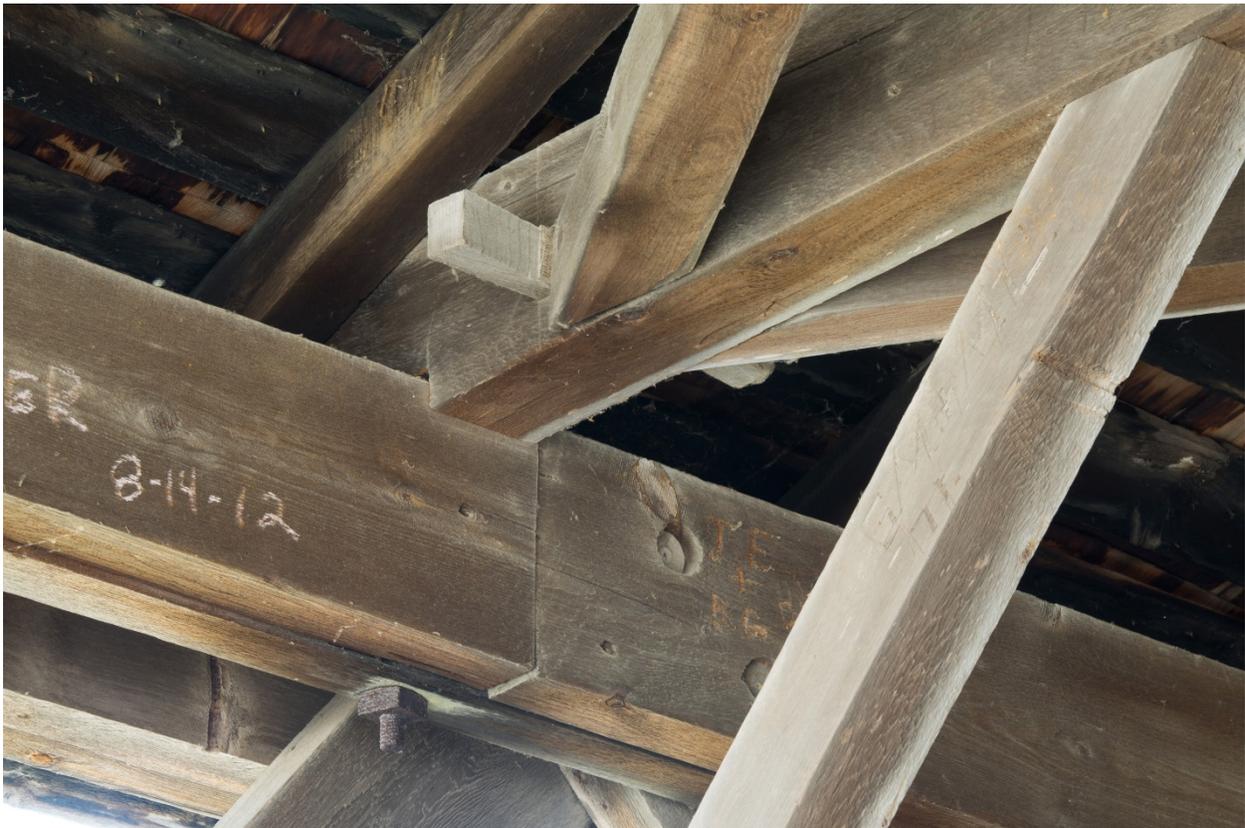
Figure 9. Interior detail west side truss connection to roof structure

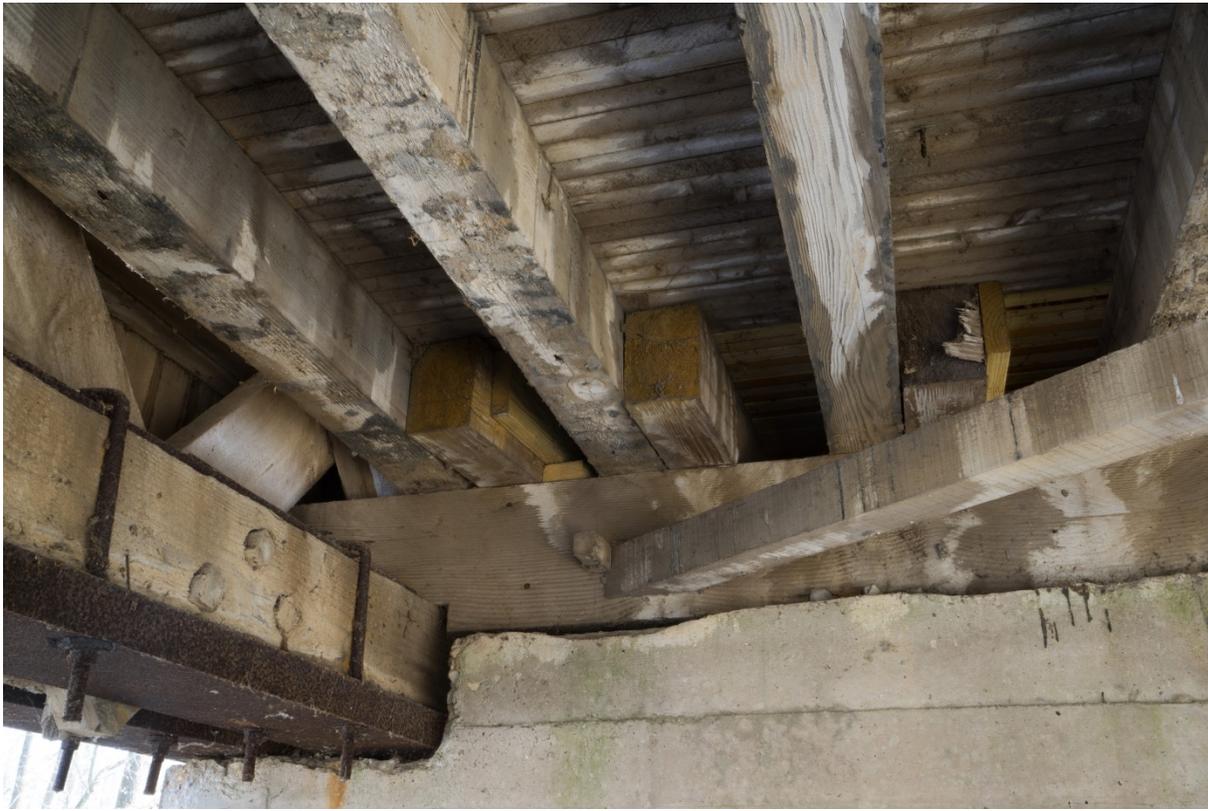
Figure 10. Detail of deck resting on concrete pier, view south

History: Town of Cedarburg constructed the bridge in 1876. The planks and timbers were milled in Baraboo, Wisconsin, and hauled 100 miles to its location spanning Cedar Creek at a point about a mile north of downtown Cedarburg, where the trusses were assembled. In 1927, a concrete center abutment was added to support vehicular traffic. The Ozaukee County Board voted to preserve the structure in 1940 as a historic monument. The bridge remained in vehicular service 1962, when it was bypassed by a modern concrete span. It is now used for pedestrian traffic as the main feature of Covered Bridge Park, managed by Ozaukee County Planning and Parks Department. The Cedarburg Covered Bridge is the last historic covered bridge remaining in the state of Wisconsin.

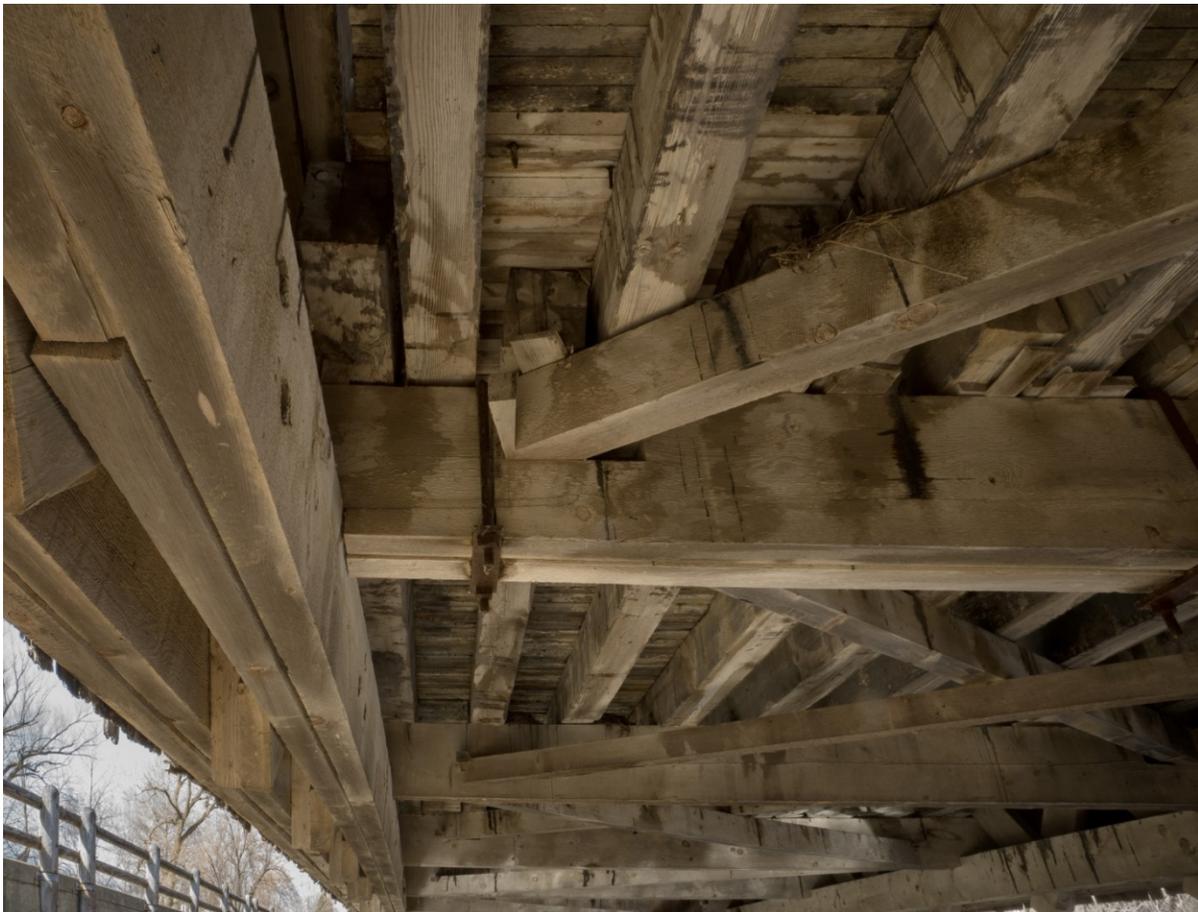
Figure 11. View of lower chord, floor beam, and lower later bracing; view to north.
