102 North Monroe Street
(Commercial Building)
Alderson
Greenbrier County
West Virginia

HABS No. WV-242

HISTORIC AMERICAN BUILDINGS SURVEY

102 NORTH MONROE STREET (Commercial Building) HABS No. WV-242

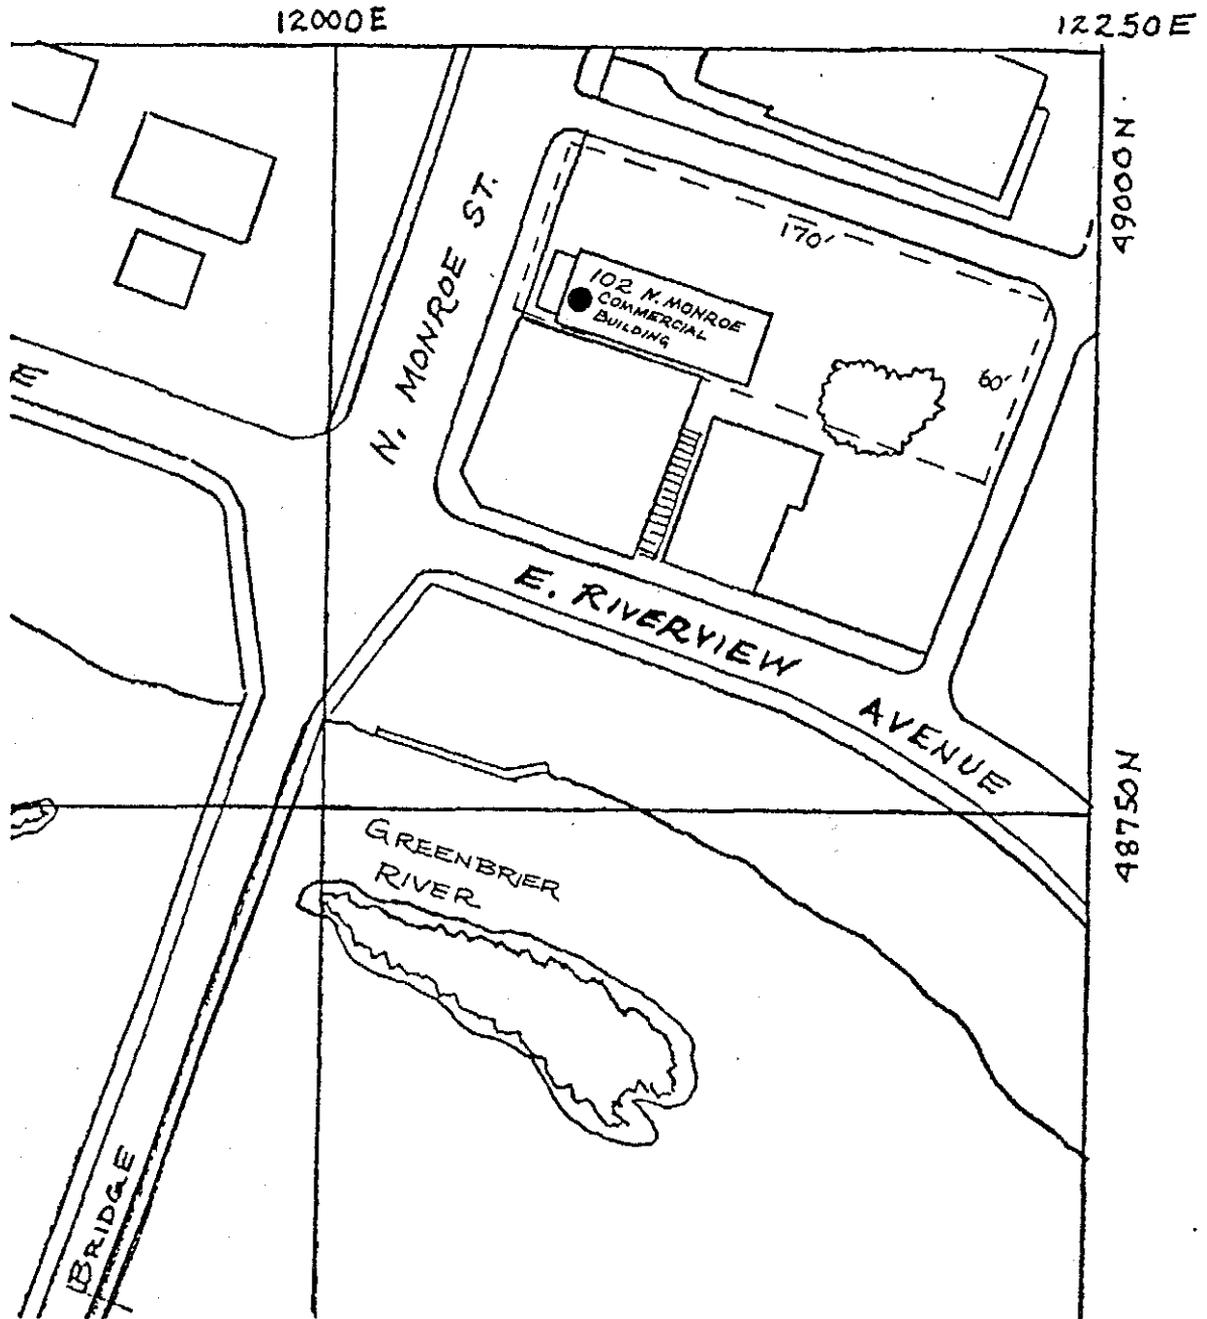
SITE PLAN (Detail)

● Denotes Subject Structure

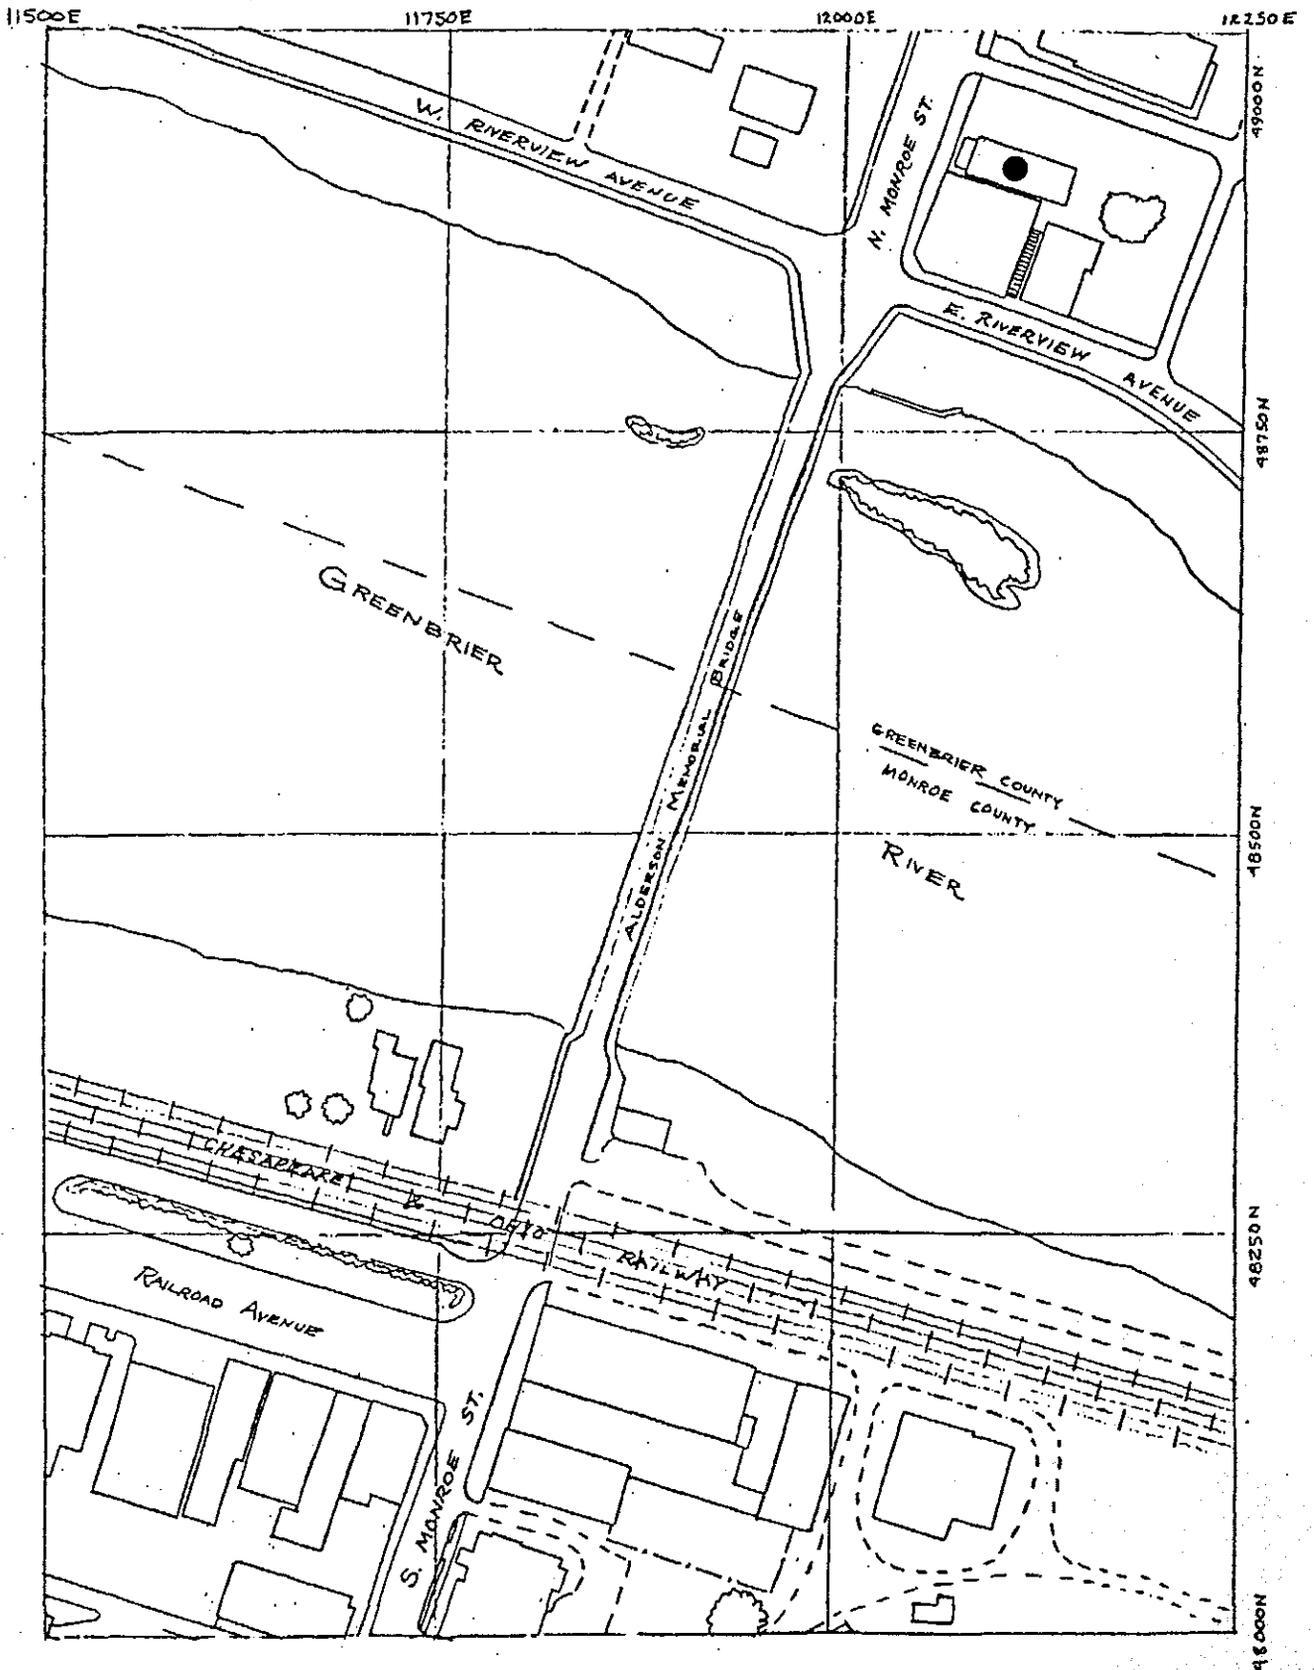
SITE PLAN

● Denotes Subject Structure
