USS *VULCAN*
(AR-5)
James River Reserve Fleet
Newport News vicinity
Virginia

HAER VA-129
HAER VA-129

USS *VULCAN* (AR-5)

HAER No. VA-129

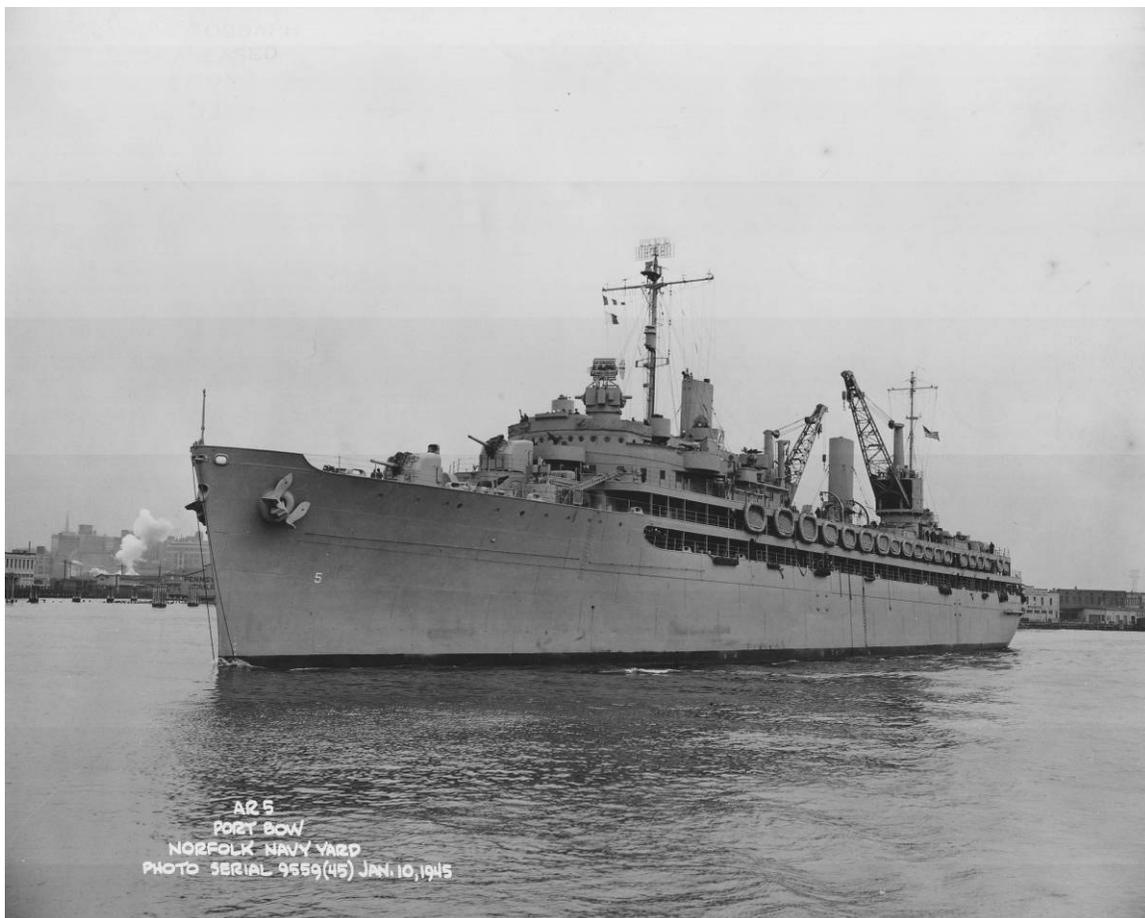
Figure 1: Caption reads: AR 5, Port Bow, Norfolk Navy Yard, Photo Serial 9559 (45), Jan. 10, 1945. From Photographic Section, Naval History & Heritage Command, Washington, DC.

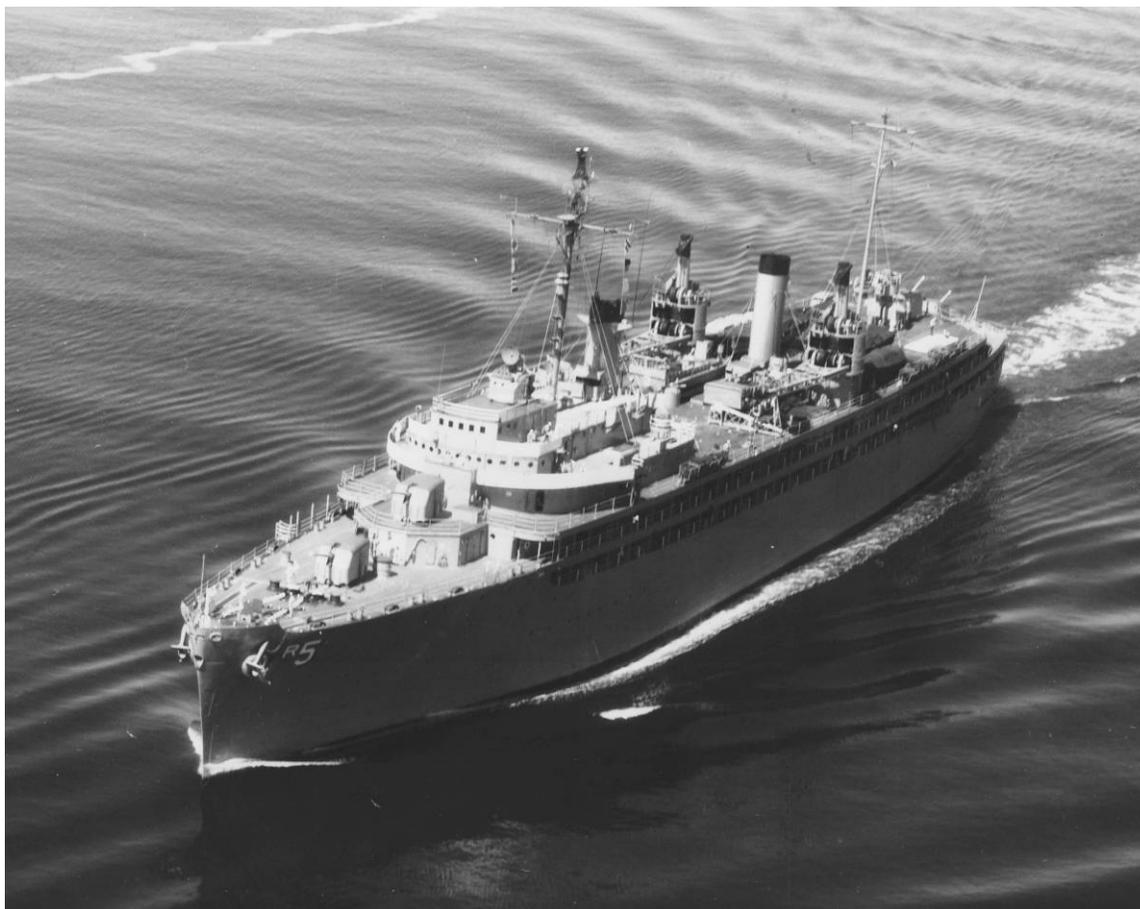
Figure 2: No caption or date. Photograph shows the *Vulcan* underway. From Photographic Section, Naval History & Heritage Command, Washington, DC.

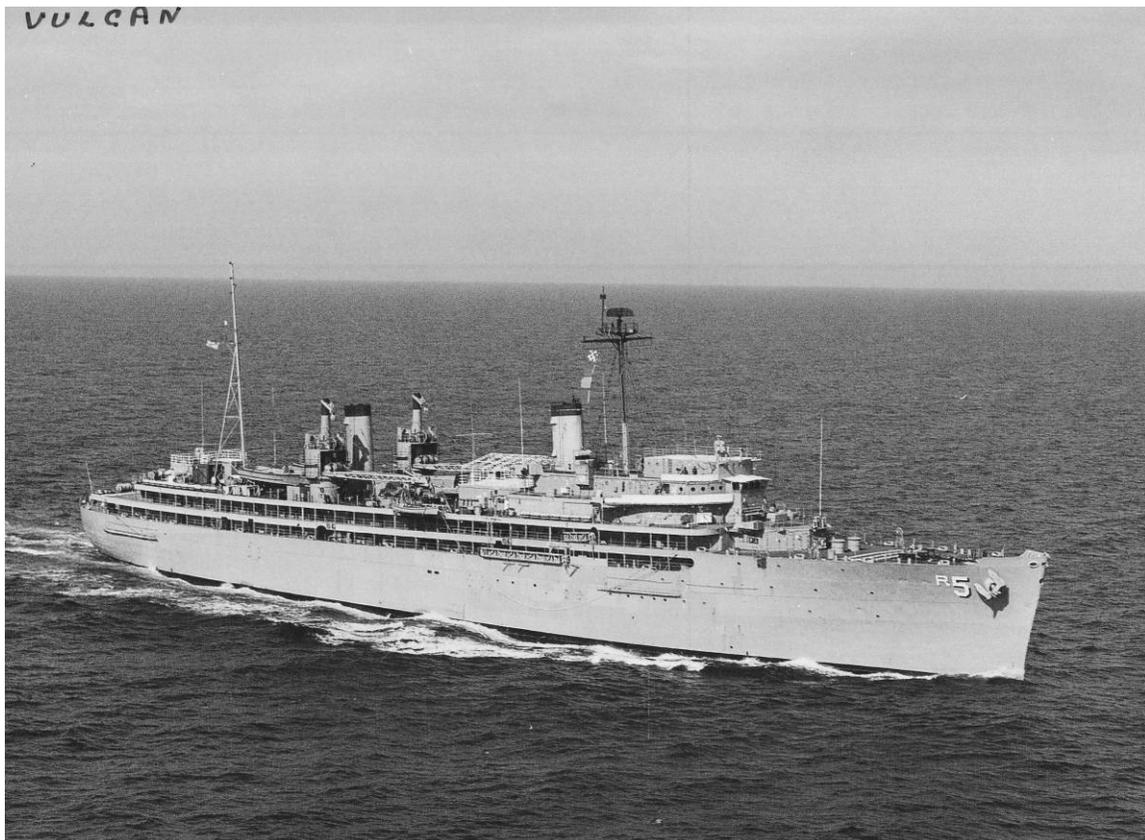
Figure 3: No caption or date. Photograph shows the *Vulcan* underway. From Photographic Section, Naval History & Heritage Command, Washington, DC.
