FORT WILLOUGHBY, GARRISON HOUSE
Virgin Islands National Park
Hassel Island Historic District
Charlotte Amalie vicinity
St. Thomas
Virgin Islands (Us)

HABS VI-90-A
HABS VI-90-A

FORT WILLOUGHBY, GARRISON HOUSE

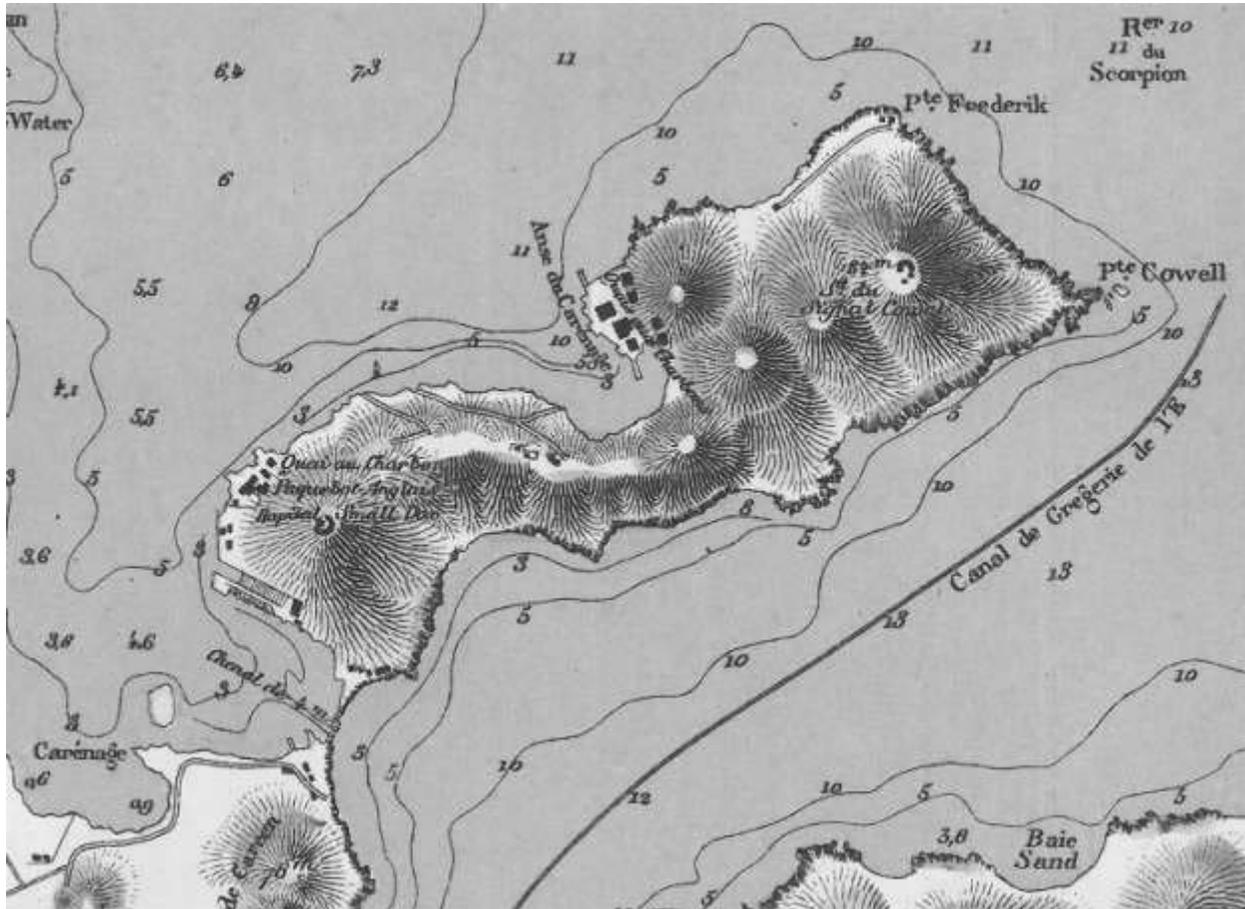
Figure 1. 1873 French Map of St. Thomas Harbor Showing Hassel Island and Garrison House.

In 1815 British troops withdrew from St. Thomas and turned the Virgin Islands back over to Denmark following the defeat of Napoleon and the signing of the Treaty of Paris. No records found for this report tell how the Garrison House was used by the government of St. Thomas after the second British occupation. The earliest map found for this report that shows the Garrison House is the 1873 French map of the St. Thomas harbor in Figure 1.
